# BELZONA CHOSEN FOR ROPE ACCESS REPAIRS TO HUGE CONCRETE CHIMNEY

ID: 9175

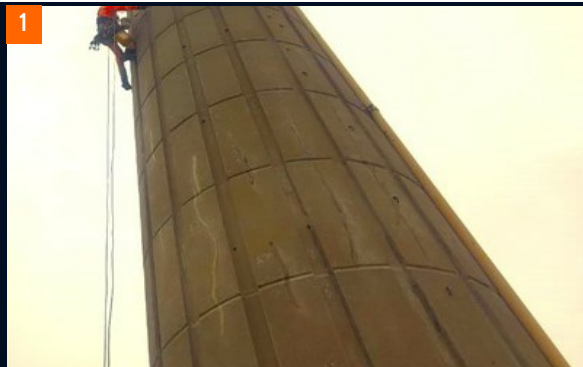
1. The work and scope made this impossible to shutter or to scaffold
2. Rope access and a lightweight repair polymer was the most preferential choice due to access difficulties
3. Completing the works
4. A rope access company who have worked with us many times, safely completing this difficult work

The areas were safely prepared prior to the application of Belzona 4911 (Magma TX Conditioner)

Whilst the conditioner was still wet, the Belzona 4141 (Magma-Build) could be applied in one hit by the Rope Access team, saving transition time from floor to target areas
