# INTERNAL FLOATING ROOF (IFR) REPAIR - BELZONA FLORIDA

ID: 9177

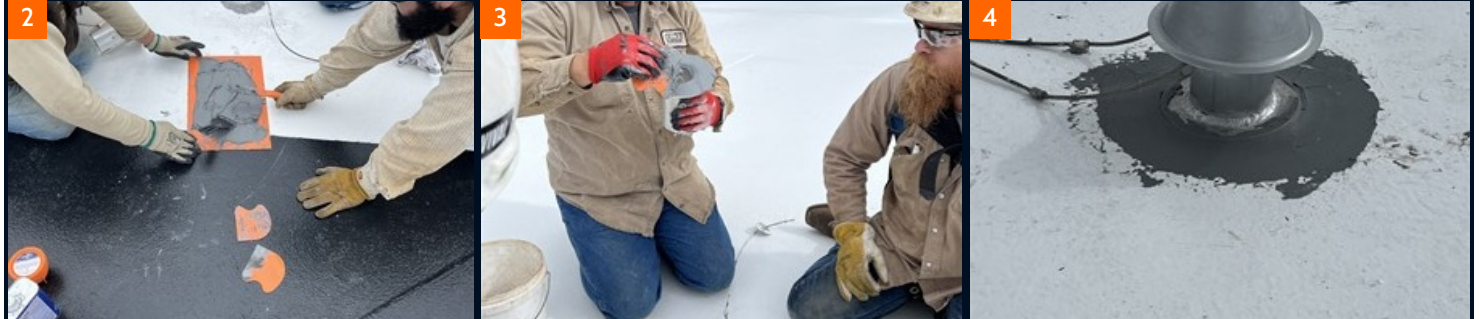
1. Area being prepped.
2. 1121 product being mixed.
3. 1121 being applied to the piece that will be bonded.
4. Finished application.

They needed an adhesive that they could trust to bond the new aluminum pieces in place. Belzona 1121 was chosen for its outstanding performance characteristics, ease of use and extended working life

Standard surface preparation through the use of an angle grinder and a carbide grinding wheel.
