# BELZONA REPAIRS AND SEALS IRON GUTTER

ID: 918

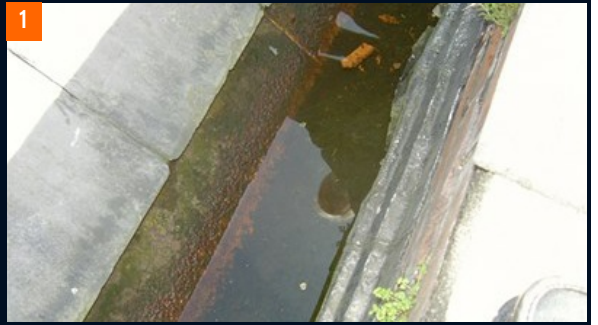
The cast iron had over time corroded and the joints deteriorated allowing water to enter the internal fabric of the building.

1. Blocked and corroded gutter
2. Gutter drained ready for preparation
3. Belzona fully reinforced Flexible Membrane system
4. Completed application
