# BELZONA 4111 REPAIRS THE FLOOR DRAIN

ID: 9181

## PROBLEM

Damaged concrete at the edge of a floor drain trough.

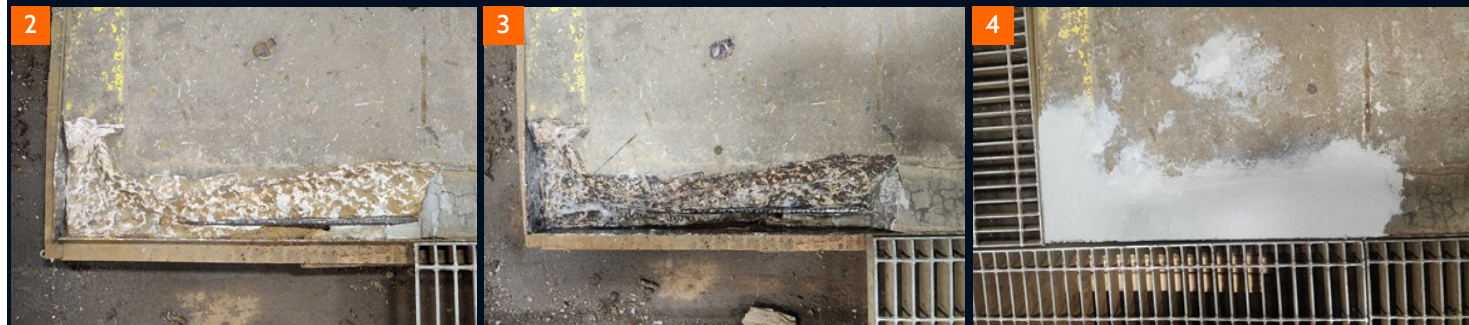
## PHOTOS

The damaged area had been repaired with another material which was not bonded to the concrete, which resulted in an additional tripping hazard as it was now raised up. This is a water test area for large vessels and requires a smooth floor to roll carts over and sees a lot of foot traffic as well. An uneven floor in this area poses a huge danger to both employees and equipment.

1. Previous failed repair material removed.
2. All loose material removed and the surface prepared with a hand grinder on both the concrete surfaces and metal surfaces.
3. Belzona 4911 Conditioner applied liberally.
4. Belzona 4111 application completed.

The previous repair material was removed in large pieces with a screwdriver as it was not bonded to the concrete. A wire wheel on a drill was used to remove all of the loose concrete debris. A 4" hand grinder with a stone grinding wheel was used to remove the rust from the metal frame and exposed rebar, as well as to remove as much of the surface of the concrete as possible. The Belzona 4911 Conditioner was liberally applied ensuring that the full area of application was fully coated into the uneven surface. The Belzona 4111 was mixed following the Instructions For Use and packed in by hand to ensure there were no air pockets or voids, and then finished using a steel concrete trowel.
