# PLATE BONDING IN MARINE BULKHEAD

ID: 9185

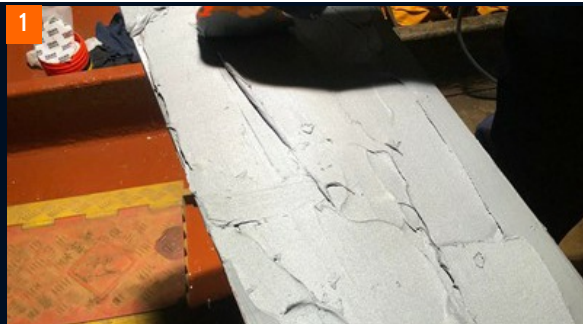
1. Belzona 1111 applied to plate
2. Substrate wet out
3. Plate applied to the corroded area
4. Overview of installation

The area was prepared with an MBX Bristle blaster. Belzona 1111 was then used to wet out the substrate & the plate. The plate was then pushed into position to reinforce the corroded area.

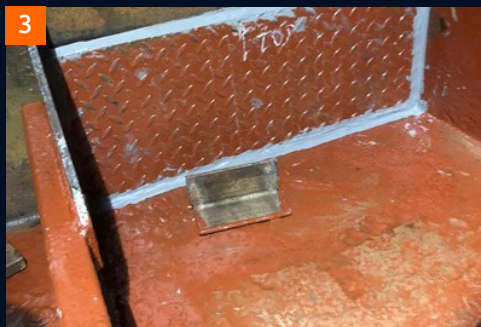
An area of corrosion had led to wall thinning on a bulkhead. Welding was undesirable due to the confined space & close proximity of fuel.
