# BELZONA ENCAPSULATES FLAT ROOF AND PARAPET WALLS

ID: 919

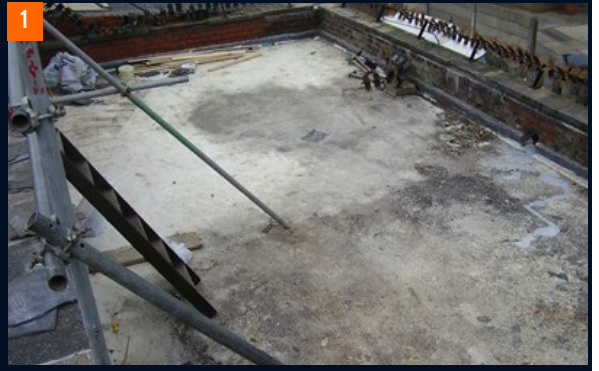
Deterioration of original felt finish had allowed water ingress into the roof deck. In particular the felt had split and cracked in critical areas such as the wall to roof interface and the water outlets.

1. Roof area prior to coating
2. Close up of parapet wall and gutter outlet
3. Belzona 3111 encapsulating roof deck and parapet wall
4. Completed Belzona 3111 reinforced system
