# FLANGE FACE REFORMING TO STOP LEAKAGE AND FUTURE CORROSION

ID: 9190

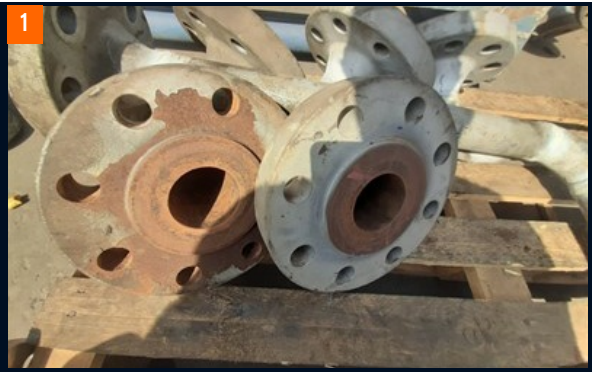
The flange faces were severely corroded and leaking.

1. Initial condition of flanges
2. Flange faces rebuilt and restored using forming technique
3. Completed application
