# PROTECTION OF PUMP IMPELLER FROM SEAWATER SERVICE

ID: 9192

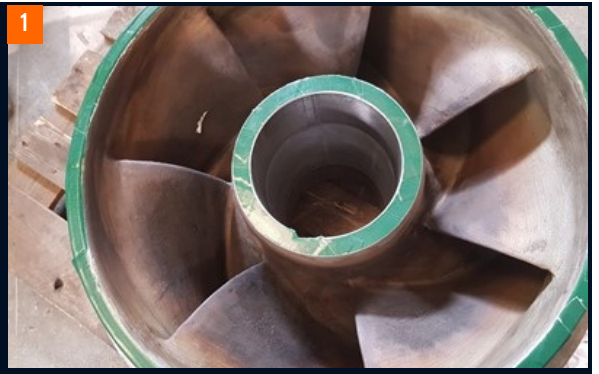
The impeller was exposed to corrosion due to unfiltered seawater as the pump medium. The customer needed a coating that could prevent corrosion and increase pump efficiency.

1. Before application
2. Close up of impeller vanes
3. Fully coated impeller for protection
4. Another angle for completed application

Grit blasting with a surface profile of 75 microns and a cleanliness of Sa2.5. Application was carried out in accordance with Belzona Know-How System Leaflet CEP-3 with two coats of Belzona 1341 according to the IFU.
