# BELZONA REPAIRS AND PROTECTS A SPLIT CASING PUMP

ID: 9193

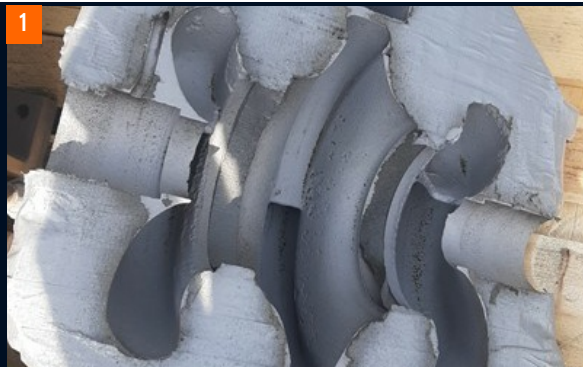
The customer noticed small cavities in the casing due to pitting corrosion during inspection and were concerned about the life of the equipment as this could lead to failure.

1. Grit blasted casing
2. Pit filling and rebuilding application prior to coating
3. Coated and protected casing interior

Application was carried out in accordance with Belzona Know-How System Leaflets CEP-3, CEP-5 and CEP-10. Belzona 1111 was applied to the pitted area and the casing was further protected with two coats of Belzona 1341.
