# BELZONA PROTECTS BUNDS AGAINST HIGH STRENGTH ACIDS

ID: 9194

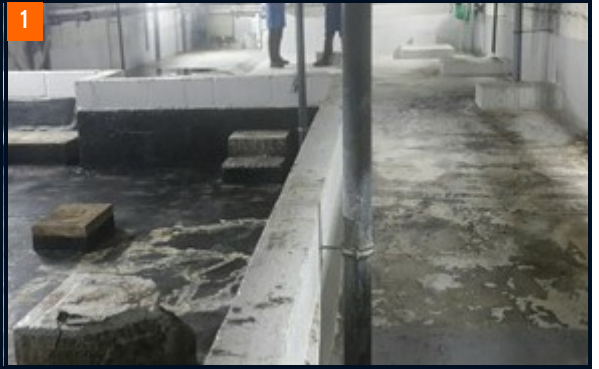
Acids were leaking into the bund at several entry points. These were breaking down the existing coating & leading to damage in the concrete substrate.

1. Corroded bund
2. Damaged sections of concrete
3. Final coat of Belzona 4311
4. Completed application
