# BELZONA PROTECTS PULSATION DAMPENER

ID: 92

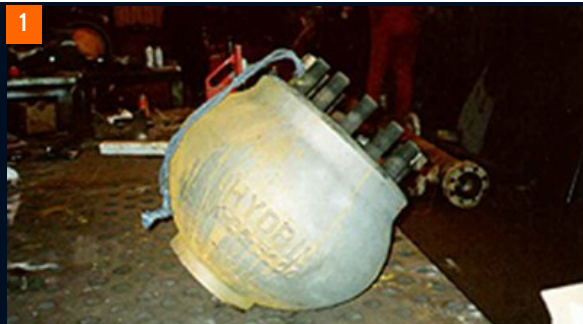
The rough surface caused by corrosion within the dampener was causing the diaphragm to be holed very quickly. This was leading to the drilling operation having to be shut down whilst the diaphragm was changed.

1. The unit after surface preparation which involved repeated washing and grit blasting to remove salt contamination
2. Application of Belzona 1391 underway
3. The completed application. The smooth corrosion resistant surface will minimise wear on the diaphragm

Application was carried out in accordance with Belzona System Leaflet VPF-2.
