# BELZONA SEALS HOLES IN SPRINKLER TANK

ID: 920

Five meter diameter fire sprinkler, water storage tank.

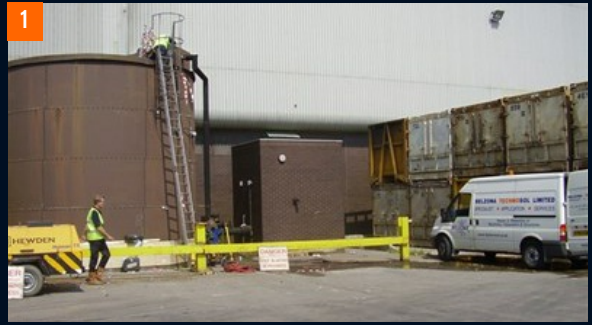
1. External view of tank
2. Water escaping through a hole in the tank
3. View of prepared substrate
4. Mild steel plates bonded to tank

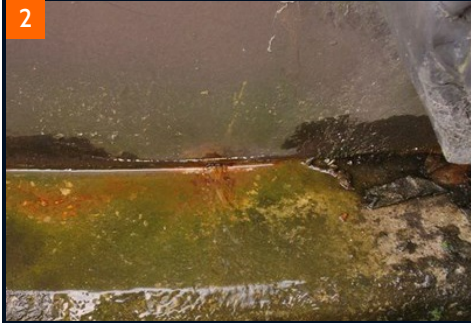
The tank was suffering from corrosion which had affected the wall thickness of the tank. In several areas this had caused holes in the tank which were now leaking. As this tank was a storage tank for water to be used for fire fighting it had to be structurally intact.
