# SUCCESSFUL TRIAL APPLICATION FOR PUMP CONE AND IMPELLER IN HYDROPOWER PLANT

ID: 9200

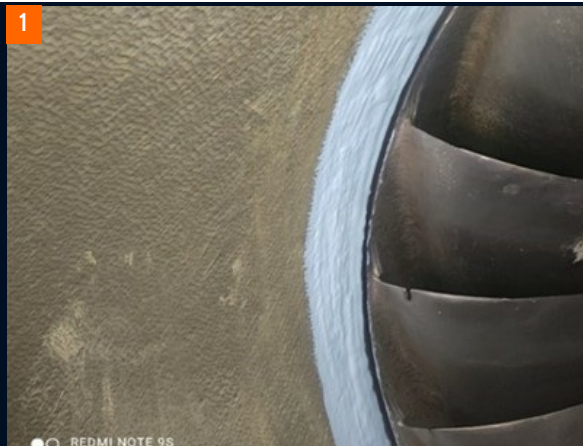
After an initial inspection was carried out by authorized personnel, most of the pump's cone and impeller were found in good conditions. However, the customer chose small, damaged areas (where cavitation was present) to perform a trial application with Belzona. The trial application involved the protection of two blades of opposite poles near the axis area to avoid any unbalance of the impeller and cone.

1. Belzona 1111 used to repair and Belzona 1341N used to protect the perimeter area of the cone.
2. Different angle of Belzona 1111 being used to repair and Belzona 1341N being used to protect the perimeter area of the cone.
3. Belzona 2911 used to condition the repair area of the impeller.
4. Belzona 2141 used to protect the impeller from cavitation.

- Brushes to be used were cut by half for an effective application.
- Belzona 1111 was mixed by volume - three parts of Base to one part of Solidifier until reaching an homogeneous color.
- Area was repaired with Belzona 1111 and left to cure for two hours.
- Belzona 1341N was mixed by volume - three parts of Base to two parts of Solidifier until reaching an homogeneous color.
- First coat was applied at a thickness of 10 mils (250 microns) and left to cure according to the Instructions for Use.
- Once past cure time, a second coat of Belzona 1341N was applied at a thickness of 10 mils (250 microns) and the application was left to cure.
