# BELZONA QUICKLY COATS AND PROTECTS ASPHALT SHINGLE COLOR PROCESS CONE/SILO

ID: 9204

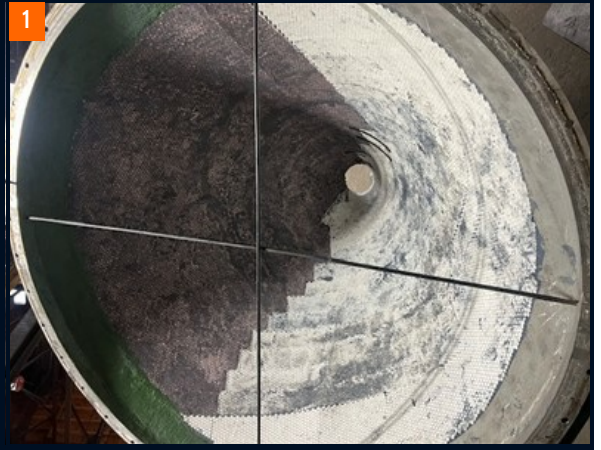
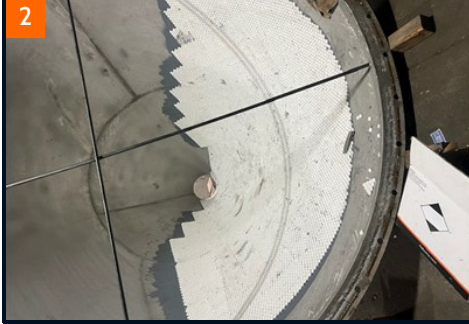
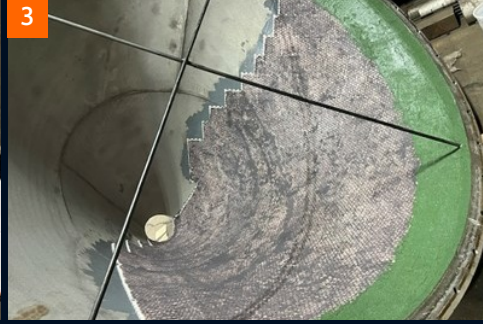
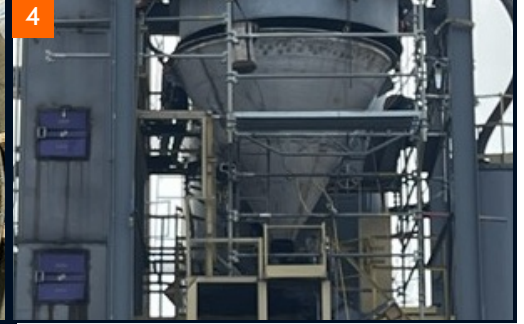
Old Silo had expired with countless holes. Addressed with makeshift patches, emitting product into the air. The customer was looking for a long term abrasion resistant solution.

Customer was looking for a long term solution for a brand new silo cone. The old cone had endured countless damages due to abrasion/erosion. Belzona was critical due to limited time frame during a plant shutdown.

Blasting took one day, and coating/application of Belzona 1321 (Ceramic S-Metal), bonding the Belzona 9811 Alumina Tiles, and grouting with 1814/1813 over the next two days resulting in a three day application process. The Cone is 255 sq ft. It was installed during a plant shutdown days later.
