# TANK BASE SEALING WITH BELZONA

ID: 921

108m diameter oil storage tank

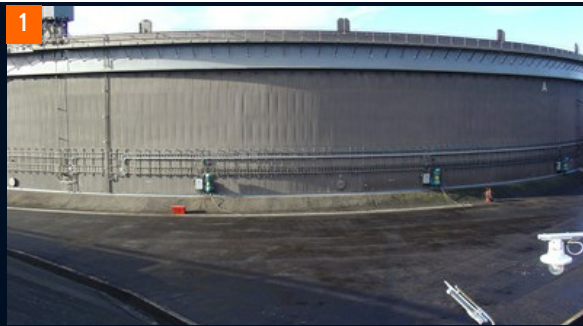
Water was penetrating under the annular ring leading to a corrosion risk.

1. Before application
2. During application
3. Belzona 3131 applied
4. Finished application

Application was carried out in accordance with Belzona Know-How System Leaflet GSS-3. Damaged areas of the concrete base were repaired with Belzona 4131 prior to the full circumference of the base being sealed with a fully reinforced Belzona 3131 system.
