# DRYER BOX - BELZONA 1813

ID: 9210

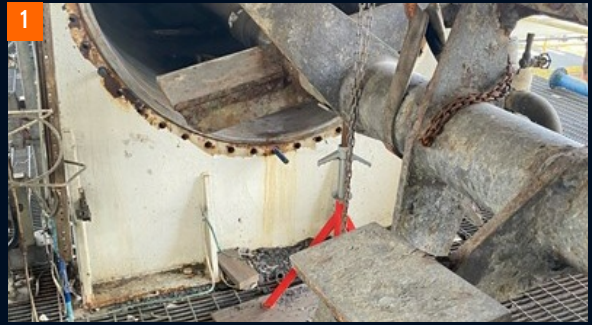
The customer needed a long term solution to protect the lower portion of a Dryer Box tank. These tanks operate at higher temperatures and face abrasive attack.

1. Dryer Box unit prior to abrasive blasting.
2. Grit blasted steel and progress of the Belzona 1813 installation.
3. Application to the belly of the Dryer Box unit.
4. Finished application of the Belzona 1813. This was allowed to fully cure prior to placing in service.

The unit was abarasive blasted to SSPC-SP10 with a minimum 3 mil dense and angular profile. The Belzona 1813 was applied with plastic applicators and trowels.
