# BELZONA REPAIRS CONVEYOR BELT

ID: 9213

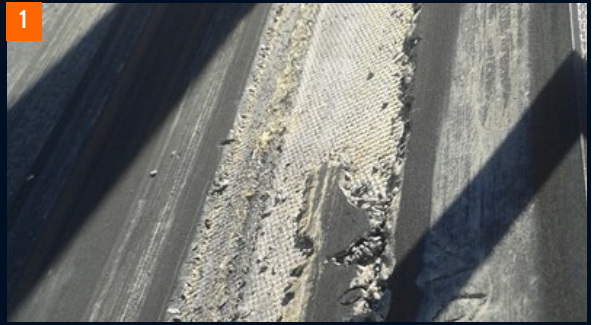
A 10 meter section of the top layer rubber on a belt wore out.

1. Condition of belt
2. After application

After abrading the belt, it was cleaned and degreased with Belzona 9111. A thin layer of Belzona 2911 Conditioner was applied to the damaged section.

Once the conditioner was touch dry, Belzona 2131 was applied and allowed to fully cure.
