# STEWART & STEVENSON - BELLHOUSING REPAIR

ID: 9225

## PROBLEM

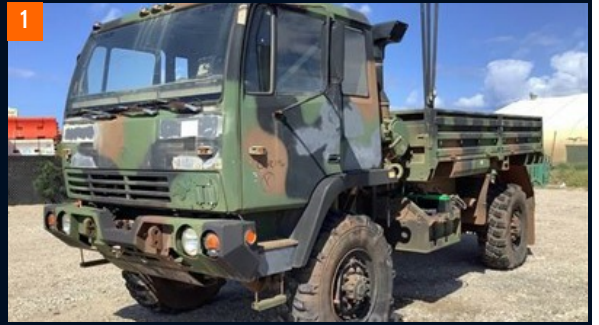
Due to inadequate maintenance; a sudden and unexpected disassembly of the universal joint and driveshaft occurred, causing significant damage to a portion of the transfer case bellhousing and affecting the performance of the oil seal.

1. Stewart & Stevenson M1078 LMTV
2. Are that broken driveshaft and u-joint impacted the case. This are is where the seal is installed.
3. The original seal was inserted and used as former to fill the damaged site. This will cast a wall for the new seal to properly preform.
4. A final wrap was done to create hoop strength, ensuring that any impacts, vibration or movement will not compromise the repair.

The repair was conducted using a customized approach based on Belzona System Leaflet ENC-01. Debris and grease were eliminated, and the surface was prepared using the MBX Bristle Blaster, followed by cleaning with Belzona 9111. The oil seal served as a former to fill the missing section of the bellhousing with Belzona 1161. Lastly, the repair was finalized by applying Belzona 9341 wrap impregnated with Belzona 1161 around the bellhousing.
