# BELZONA FLORIDA REPAIRS WATER DISCHARGE FLANGE

ID: 9237

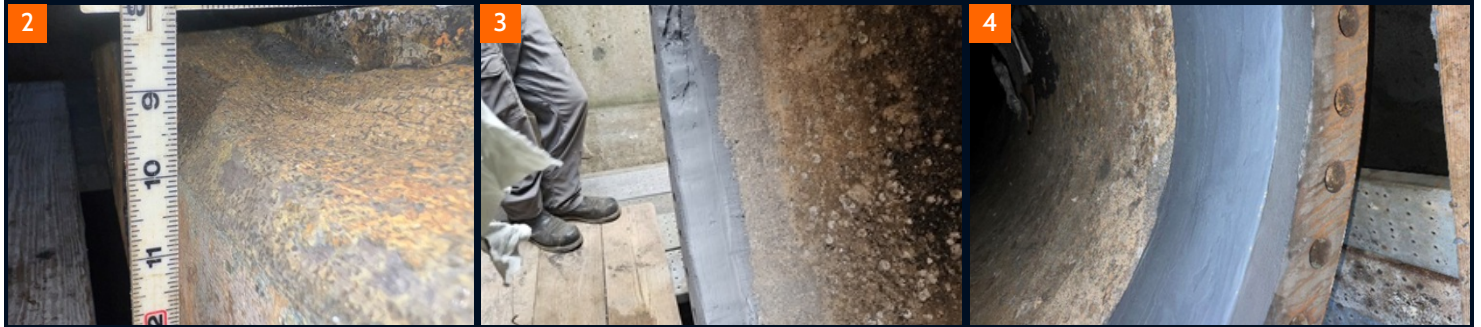
The customer had a non-Belzona coating previously applied that failed, causing corrosion scaling on the interior edge of the flange.

1. Showcasing and measuring the damage caused by the corrosion.
2. Showcasing and measuring the damage caused by the corrosion.
3. Rebuilding the damage using Belzona 1111.
4. Application of Belzona 1321.

Removed corrosion scaling with pneumatic chipping guns and needle scalers. A high pressure grit blaster with 24 grit aluminum oxide was utilized to obtain a SSPC SP-10 level of cleanliness with a minimum surface profile of 3 mils. Keane-Tator Surface Profile Comparator grit was used to verify the surface profile. The area was then soaked with demineralized water and left to sit overnight to allow chlorides to leech out. Then it was brush blasted with 30 grit aluminum oxide back to SSPC SP-10.
