# LINDE INTERCOOLER REPAIR

ID: 9242

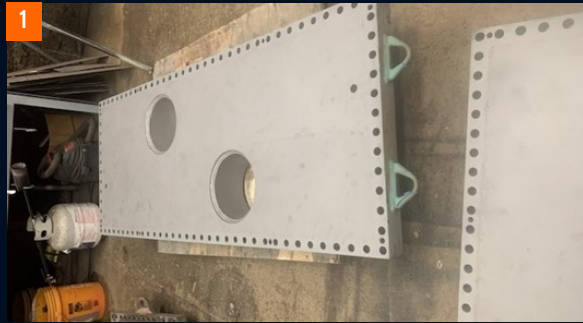
Intercooler tube sheet and end covers had corrosion due to b-metallic corrosion.

1. Before application
2. Overview of application area
3. Final application

The application was carried out in accordance with Belzona Know-How Sustem Leaflet HEX-1 for repairing eroded-corroded tube sheets.. The surface was prepared by grit basting and the surface was washed with Belzona 9111. The tubes were plugged with rubber stoppers and Belzona 1111. The second cost of Belzona 1321 was applied in accordance with Belzona Instructions for Use.
