# BELZONA REPAIRS & PROTECTS A PROCESS GAS KNOCK OUT DRUM IN A STEEL MANUFACTURING PLANT

ID: 9246

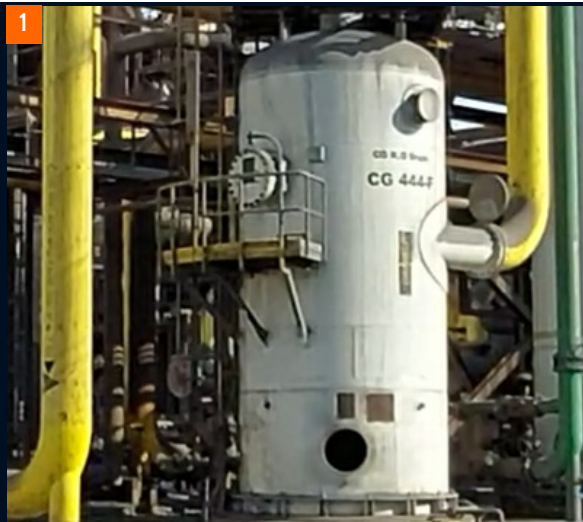
1. General view of the vessel
2. The internal surface before application
3. Rebuilding the surface after grit blasting.
4. Applying 2 coats of Belzona 1391T
