# WEATHERPROOFING ROOF RIDGE CAP

ID: 9248

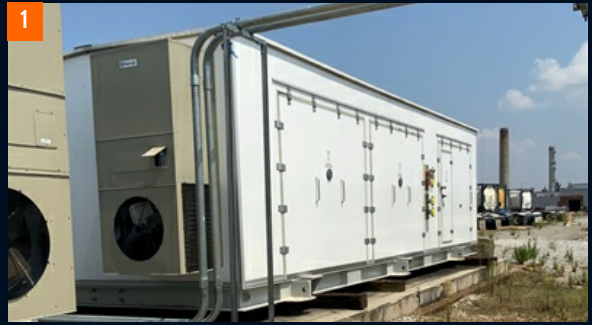
In the pictures below you will see a fiberglass housing unit for power supply in a local chemical plant. These units each have an aluminum ridge cap on the roof that comes from the manufacturer siliconed to the fiberglass panel. During transportation they become loose due to the flexibility of the fiberglass and from just being in the weather constantly the silicone deteriorates causing a leaking hazard inside the unit. This can and has caused major power outages inside the plant.

1. Rectifier Housing
2. Aluminum ridge cap coated with Belzona 3121
3. Final application
