# BELZONA REPAIRS 600-METRE LONG STEEL PLANT CONVEYOR BELT

ID: 9249

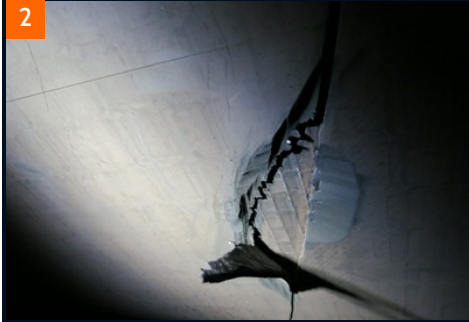
The 600-metre long conveyor belt transports the iron ore to the blast furnace. The belt costs more than 200.000 euros. It takes at least 2 days to replace it. The loss of production costs about 100.000 euros per hour !!!!. After about 8 years of operation, the belt was already so badly worn in some places that the steel belts had become visible.

1. Conveyor Belt to repair.
2. Damage to Belt
3. Damage to Belt
4. Completed Application
