# SANDSTONE MULLION REPAIRS WITH BELZONA

ID: 925

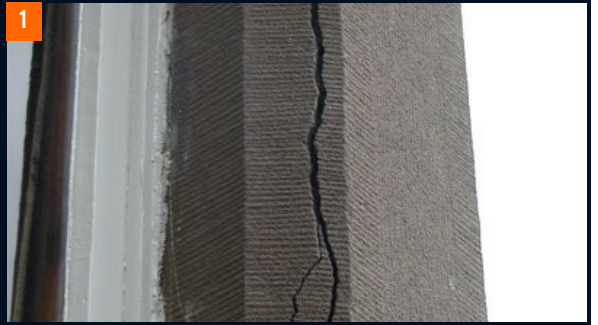
The cracks were getting worse due to frost damage in the winter months and previous attempts at concrete repairs had failed at the bond lines.

Householder had a problem of cracks in the sandstone Mullions of his bay windows.

1. The problem. Note the grooving of the sandstone.
2. Belzona 4141 being applied as a skim coat.
3. Finished application.
4. Inspected December 2007.

Application was carried out in accordance with Belzona Know-How System Leaflet WPA-4. The cracks were opened out and filled prior to the whole mullion being skimmed with Belzona® 4141 tinted to match the colour. The original grooving on the stone was replicated in the Belzona® 4141.
