# BELZONA COLD BONDS HOLED STEAM PIPE

ID: 9250

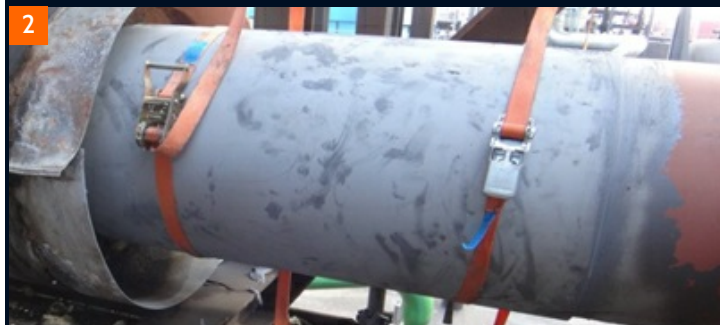
The client in the Steel industry suffered a through wall hole in their steam pipeline.

1. Defect in the pipe
2. Plate bonded on with Belzona 1511
3. Complete application overcoated with Belzona 5892
