# BELZONA 5811 & 3121 SEALS STAIR LANDING FROM FUTURE LEAKS

ID: 9257

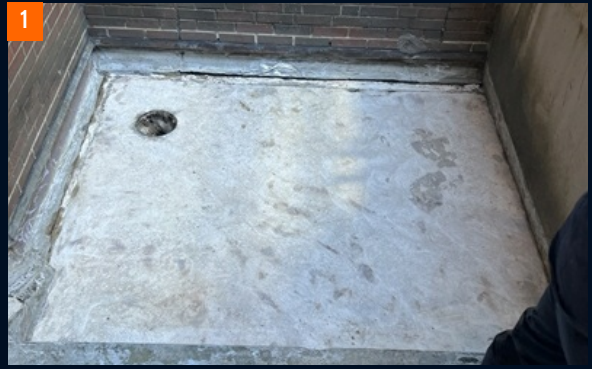
1. Old Coating was removed and floor was taken to bare concrete by a diamond grinder.
2. Belzona 5811 as our base coat to the "basin"
3. Belzona 3121 with Reinforcement cloth to the seams
4. Final product

After removing the thick mat-like coating that had bubbled and failed, we prepared the concrete floor and 8" up the wall with a diamond grinder to achieve desired substrate. We then proceeded with building a 2" cove out of Belzona 4111 to the seam where the wall meets the floor on all sides. Next, we applied 1 coat of Belzona 5811 to the floor and up the walls 8". After curing we painted an 8" strip bridging the floor to the wall out of Belzona 3121 engrained into reinforcement cloth finishing with a second coat of Belzona 3121. 3 weeks later and heavy rains, they are not experiencing any more leaks.
