# BELZONA PROTECTION FOR GEARBOX INTERNAL

ID: 926

Fifteen ton gearbox from ball mill used to pulverize coal.

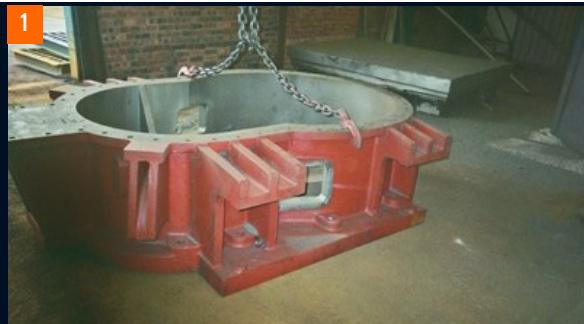
1. Bare gearbox in workshop
2. Application of Belzona 5891 underway
3. Application complete
4. Assembled gearbox ready for service

The application was carried out in accordance with the Belzona Know-How System Leaflet TCC-5. Special attention was paid to surface preparation, particularly with regard to removing all impregnated oil and achieving correct grit blast profile.
