# BELZONA RESTORES AND PROTECTS SEAWATER FILTER UNIT

ID: 9260

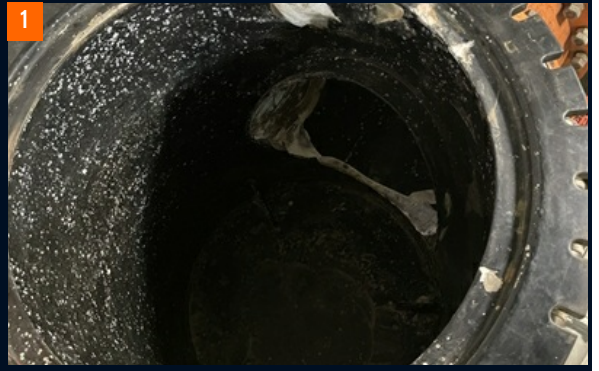
Existing internal glass flake lining of this seawater filter had failed completely. Large fragments of peeled coating was causing obstruction issues in pumps and cooling water systems.

1. Flaking and damaged lining
2. First layer of Belzona 1321 Ceramic S-Metal in progress
3. Second layer of Belzona 1321 Ceramic S-Metal in progress
4. Application Completed.

The surface was manually prepared using a combination of UHP water 2500 bar and rotatory wire brush powered tool followed by 2 coats a 400 µm Belzona 1321 Ceramic S-metal
