# BELZONA LINES A BUND.

ID: 9261

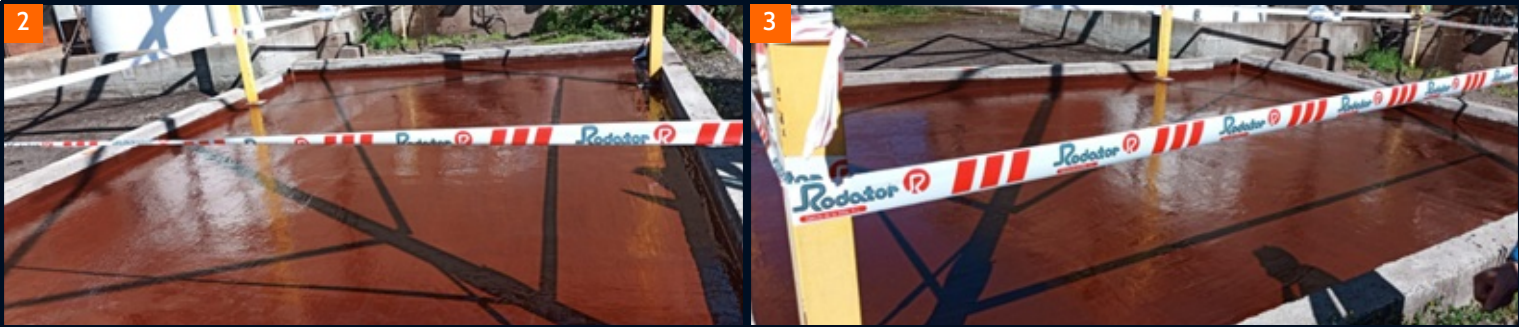
Previous exposure to the acid had caused the concrete to degrade and it was evident to the customer that this needed rectifying.

- 1. Surface Preparation
- 2. Application Completed
- 3. Application Completed

Alternative solutions involved the relaying of concrete, which would be a costly and time-consuming process and wouldn't help mitigate the source of the problem - resistance to the 98% Sulphuric acid.

The application was carried out as per the instructions for use and the systems leaflet. With the application onto the concrete done when the surface was cooling as to minimise outgassing.

Belzona was able to offer a material that is able to withstand the harsh conditions associated with the potential exposure to the sulphuric acid, while negating the need to replace the concrete.
