# BELZONA REFURBISHES DN 500 FISHFARM SEAWATER PUMPS

ID: 9264

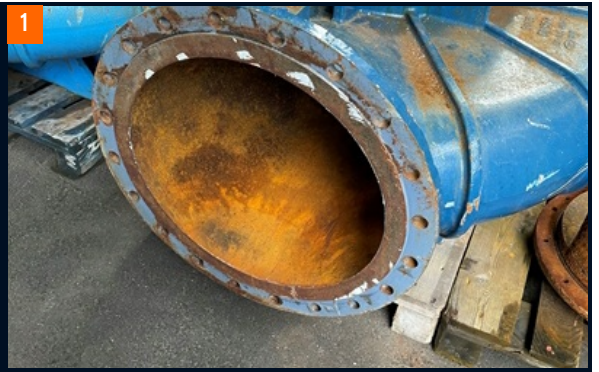
Seawater pump housings was suffering from internal corrosion and local erosion after a short period in service. In order to prevent breakdown of the pumps, the customer urgently decided to rebuild and protect the internal surfaces.

1. Corroded pump housings
2. Grit blasted details
3. Rebuilding in progress
4. Coating application completed.

1. The pump housings was internally grit blasted to SA-2,5 with a minimum surface profile of 75 microns according to ISO 1805-1
2. Corroded and worn areas was rebuilt and restored using Belzona 1311 Ceramic R-metal
3. A second grit blasting of both internals and externals to SA-2,5 with a minimum surface profile of 75 microns according to ISO 1805-1 was carried out.
4. Internal surfaces was coated with 2 layers a 375micron of Belzona 1321 Ceramic S-metal.
