# EXTERNAL CORROSION PROTECTION FOR GAS INSULATED BUSBAR

ID: 9265

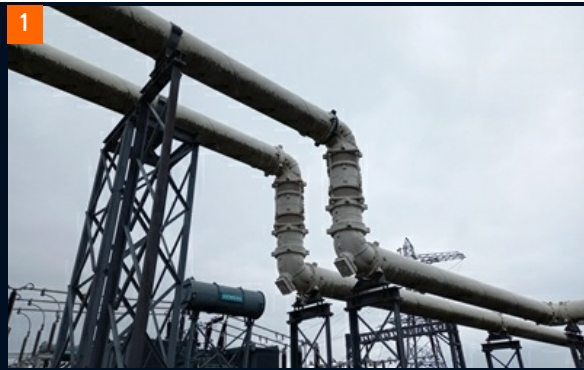
This Gas Insulated Busbar (GIB) is in an exposed coastal environment, there was concern that breakdown of the existing paint system & subsequent corrosion could occur on the flange & bolts. A system was needed to provide long term protection for these areas.

1. Complex geometry around the flanges
2. Access, cleaning & roughening of existing system
3. Belzona 5111 1st coat
4. Completed application at a later date after a rain shower. Rainwater shedding from the surface.

The areas were first cleaned then the existing paint system was roughened. Belzona 3921 GSC Conditioner was used as a primer followed by two coats of Belzona 5111 Ceramic Cladding.
