# BELZONA 7311 COLD PLATE BONDING ON TRUNNION

ID: 9266

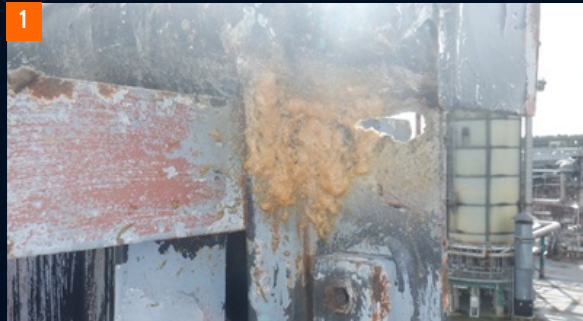
Corrosion had occurred on a trunnion section leading to significant metal loss

1. Corroded section covered in wax oil
2. Surface preparation & wetting out with Belzona 7311
3. Doubler plates installed & clamped in place
4. Completed repair overcoated
