# BELZONA CHILLER REPAIR THAT WAS COMPLETED IN ONLY ONE DAY!

ID: 9268

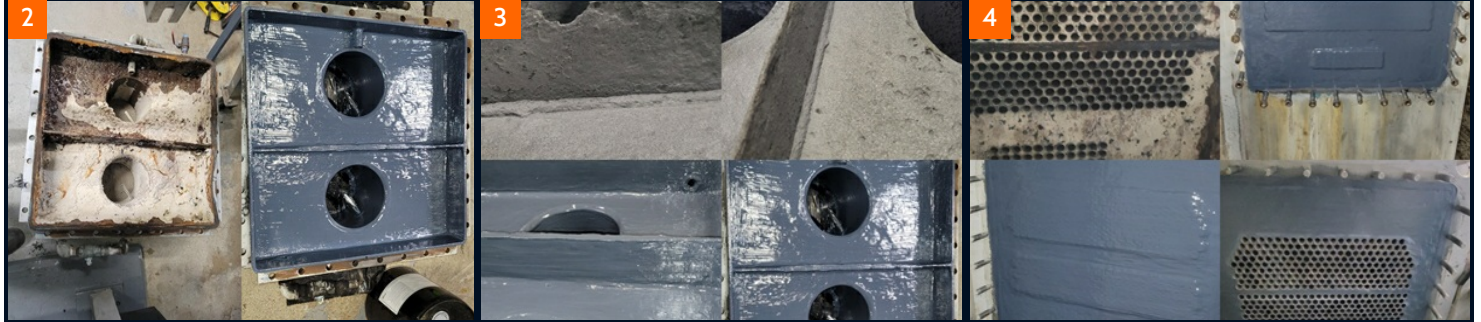
This chiller has been running uncoated since new for years in a building in downtown Dallas. Bad water treatment has left the chiller with a lot of damage and build up.

1. Before and after Belzona application
2. Before and after Belzona application
3. Before and after Belzona application
4. Before and after Belzona application

This chiller had no efficiency left . It was decided to do a full Belzona repair system on it. First the chiller was cleaned and then grit blasted. Belzona 1121 was used to repair holes and metal loss in the chiller face. After that Belzona 1321 two good system was applied to chiller . Belzona was left to dry and it was finished off by taking out the corks out of the tubes and finishing up the repair.
