# BELZONA ELASTOMER REPAIRS TO AGITATOR IN FGD UNIT

Agitator blades in crystalization tank which is an important component of the Flue Gas Desulfurization (FGD) unit.

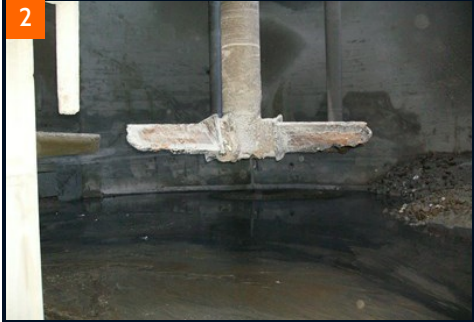
Rubber clad blades damaged through impact and abrasion. Each shaft has three blades and there were four shafts.

1. General view of the plant
2. The Crystalization Tank Mixer
3. Application crew in action
4. Completed application
