# FOOD MANUFACTURING FACILITY HAS BELZONA REPAIR END QUOTE REFRIGERATOR FLOOR

ID: 9270

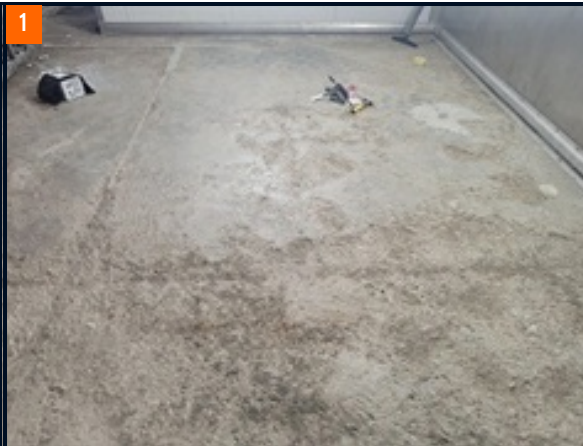
The floor in this refrigerator has been sitting on sub zero temperatures for 25 years. Constant freezing and unfreezing has left the concrete floor in very bad condition. In some areas it had up to two inches of concrete loss.

1. Area prior to application
2. Commencement of application
3. Belzona 5811 applied to area
4. Application completed
