# BELZONA PROTECTS BUND AREA SUBJECT TO CHEMICAL ATTACK.

ID: 9273

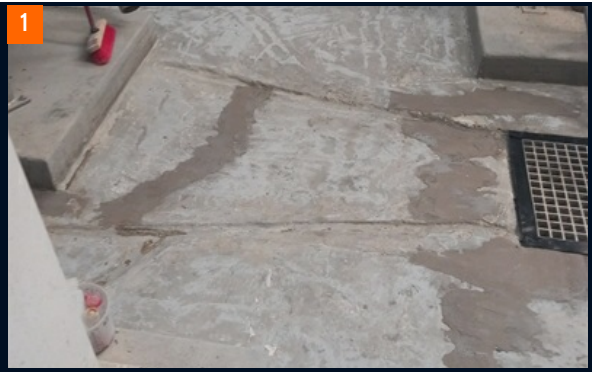
Previous coating of bund had failed due to contact with Ammonium Sulphate, causing significant damage to concrete in bund area. Customer choose Belzona after a recommendation from a colleague who had experience with Belzona in a previous role.

1. Cracks in concrete of bund area
2. Prepared edges of plinths
3. First coating
4. Finished surface

- Grinder with diamond blade used to produce a stable, firm surface suitable for lining.
- Belzona 4911 used as a primer.
- Belzona 4131 used to rebuild and repair honeycombing and blowholes in concrete.
- Belzona 5811 chosen as floor coating due to excellent resistance to Ammonium Sulphate.
