# EMERGENCY SEAWATER BUTTERFLY VALVES APPLICATION USING BELZONA SUPERWRAP II

ID: 9274

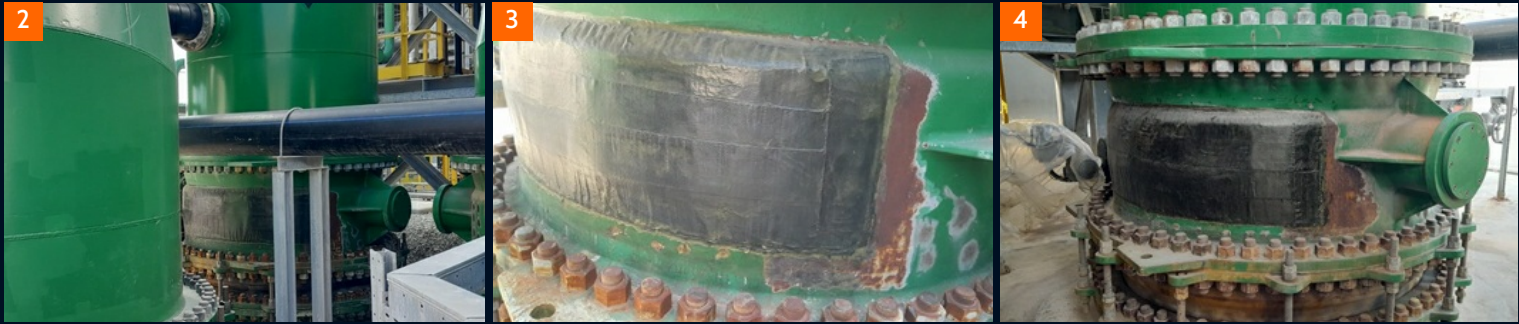
**PHOTOS**

1. A wider view of the power plant
2. The location of the butterfly valve
3. The completed application
4. The completed application

The proposed Belzona solution involved surface preparation by sandblasting inside, degreasing with Belzona 9111, repairing holes using Belzona 1161 and Belzona 9341, in addition to metal patches. Surface treatment included applying Belzona 2911 conditioner (8 boxes) and a layer of Belzona 2211 (45 boxes) over a 60x150 cm area. For the exterior, Belzona 1161 and Belzona 9341 covered the prepared surface (60x150 cm), followed by a patch using Belzona Superwrap II. The total Belzona used included Belzona 9111 (12 boxes), 1161 (107 kg), 9341 (40 m), 9341 (42 m), and Belzona 1982 (9 litres). Application involved 2 wraps and took 12 days with a team of 3.
