# BELZONA REPEATEDLY OFFERS REBUILDING AND EFFICIENCY COATING SOLUTIONS FOR OEM PUMP MANUFACTURERS

ID: 9278

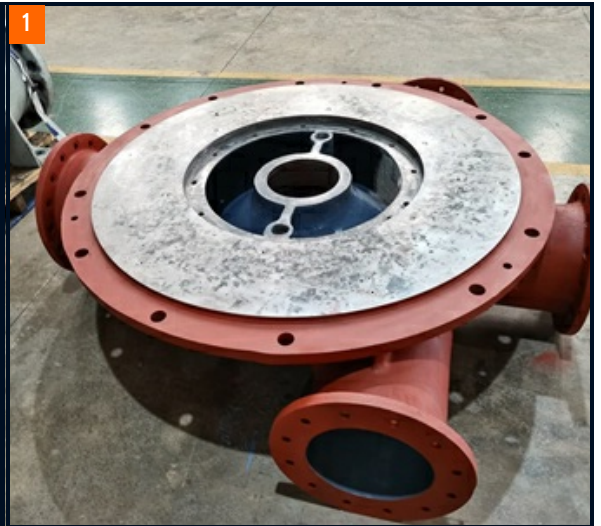
1. Pump efficiency improved with Belzona 1341 (Supermetalgilde)
2. Split casing pump repaired and protected with Belzona
3. Split casing pump repaired and protected with Belzona
4. OEM Pump Manufacturers offer repeat business for Belzona in South Africa

There has been a variety of work repairing and protecting pumps for this client. In one example, recently repaired a split casing pump for a customer with Belzona 1111 and Belzona 1341. This pump will have a much improved efficiency, thus reducing its Kw's absorbed, reducing amps, and saving our customer money which in a country with massive power problems is a necessity. Belzona 1391T was also used on pumps that did not require efficiency improvement.
