# BELZONA 2211 SEALS 550 SUPPORT PADS ON A CARBON STEEL PIPELINE TO PREVENT CREVICE CORROSION

ID: 9283

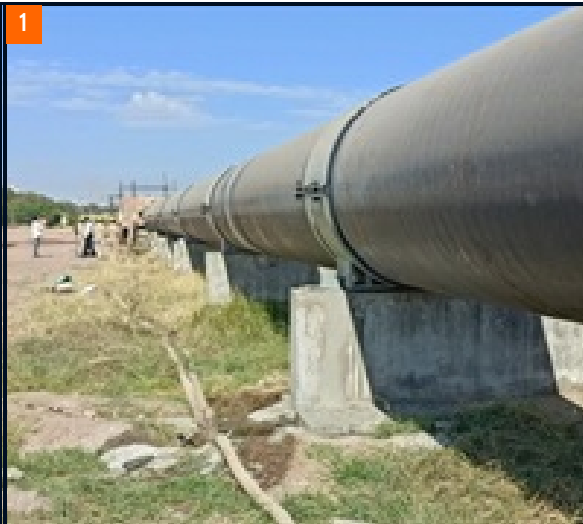
Water ingress had caused localised corrosion on the metal pads that support the joints of a 45 km-long, 60-inch-diameter carbon steel pipeline. The client was looking for a solution to fill these gaps and prevent any risks of water ingress for over 500 support pads.

1. Carbon steel pipeline in question
2. The application on one of the support pads in progress
3. A gap on the pipeline sealed with Belzona 2211 to prevent water ingress
4. Close-up photo of completed application
