# BELZONA REPAIRS AND PROTECTS VACUUM PUMPS FROM CHEMICAL ATTACK

ID: 9284

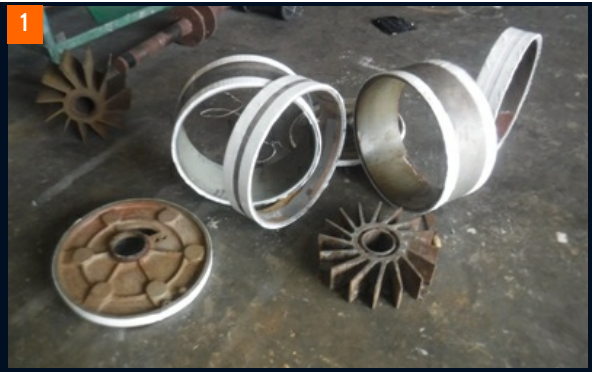
The vacuum pumps in oil and gas industry were damaged by Chlorobenzene (CB) attack.

1. Disassembled pump components
2. After sand blasting
3. The impeller rebuilt with Belzona 4301
4. The suction and discharge disks after coating with Belzona 4311

1. The vacuum pumps were disassembled into its individual components in preparation for repair.
2. The surface preparation was done by sand blasting.
3. The pump components were rebuilt with Belzona 4301 and coated with Belzona 4311.
4. After the products were fully cured, the repairs were machined back to their original dimension before reassembling.
