# CABLE REPAIR CONDUCTED WITH BELZONA 2221!

ID: 9287

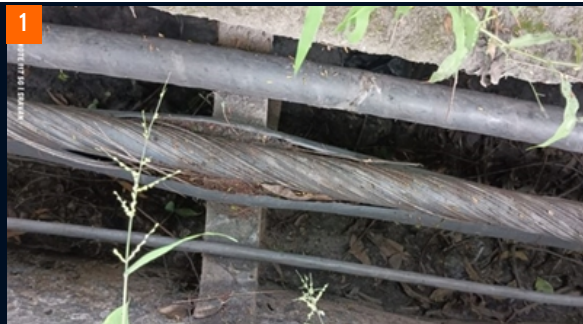
The underground mines cable outer sheets had become damaged due to very rough mining surface and dusty conditions. These mines are situated 200 to 500 metres deep, and damage like this can cause serious issue for water ingress.

1. The damaged cable
2. After surface preparation and Belzona 2921 (Elastomer GP Conditioner) was applied
3. Finished application with Belzona 2211 (MP Hi-Build Elastomer) applied on the damaged areas.
