# 350,000 TIN ROOF BOLTS COATED WITH BELZONA FLEXIBLE MEMBRANE

ID: 9289

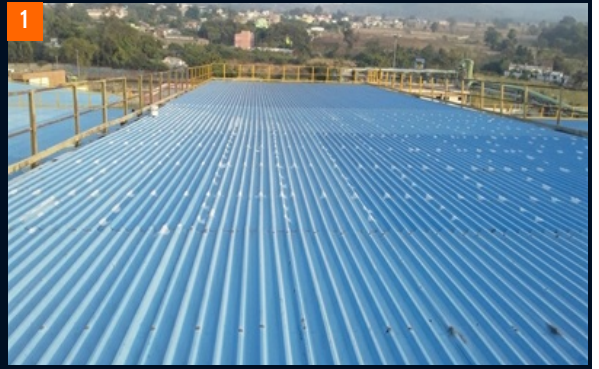
Water was leaking from the anchoring bolt joints and overlapping joint area of a cast house pot room overhead tin roof.

1. Tin roof required a repair on anchor bolts and joints to prevent water ingress
2. The repair on the roof in progress
3. The tin roof bolts sealed with Belzona 3111
4. The tin roof bolts sealed with Belzona 3111 to prevent water ingress

Firstly, the colour was stripped from the tin roof and the surface was thoroughly cleaned using a wire brush.

Belzona 3921 (GSC Surface Conditioner) was applied to the application area and allowed to dry. Later, Belzona 9311 (Reinforcement Sheet) was placed around the anchor bolt and joint area prior to the application of Belzona 3111 (Flexible Membrane.)
