# BELZONA COATS STACK WHILST IN SERVICE

ID: 929

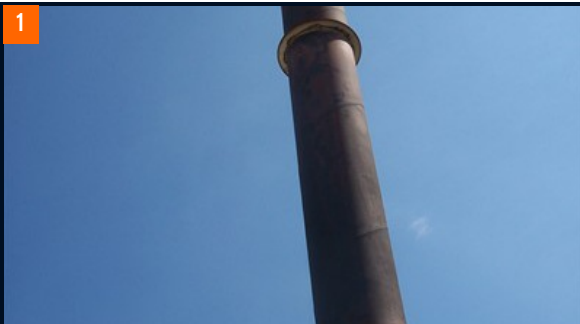
External corrosion protection required but stack could not be taken out of service.

Vent stack for hot gases operating between 300 & 550°F (150 & 280°C) internal temperature.

1. Original chimney
2. Test strip - top portion, bottom - burned portion
3. Final application - 4 months later

Brush applied with a 4" bristle brush by hand.

Belzona 5851 (HA-Barrier)
