# CO2 ABSORBER RUBBER LINING REPLACED WITH BELZONA COATING SYSTEM

ID: 9290

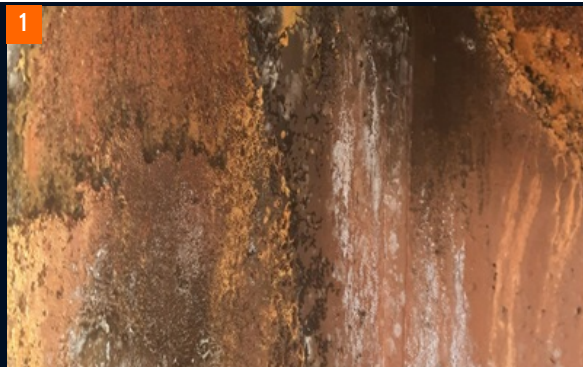
The rubber lining of the CO2 absorber was swelling, blistering and crackings throughout the tank interior. Corrosion damage to the base metal was so pronounced that it could be glimpsed through cracked/delaminated rubber lining.

1. Traces of severe corrosion from under the rubber lining
2. Coating application in progress to the manway and flange
3. Manway and flange coated and protected
4. Protected tank interior after application

The damaged rubber lining was replaced with a Belzona epoxy coating system. The original system thickness requirement by the customer was a minimum of 2 mm, as the previous rubber lining was 3 mm thick. The proposal initially considered was a 2 mm thick build-up with Belzona 1111, but it was too costly and over budget to cover the entire interior surface, so Belzona 5811 was used for the build-up instead of Belzona 1111.

Three coats of Belzona 5811 (Immersion Grade) were applied as filler and to cover the wall loss. Belzona 1331 was applied as the final top coat. Each coat was applied using an airless spray machine. The materials were applied in accordance with the relevant Instruction For Use and the guidance of approved method statement.
