# BELZONA 4111 FILLS THE CONCRETE CRACKS IN WAREHOUSE FLOOR TO MAINTAIN SAFETY IN WORKPLACE

ID: 9291

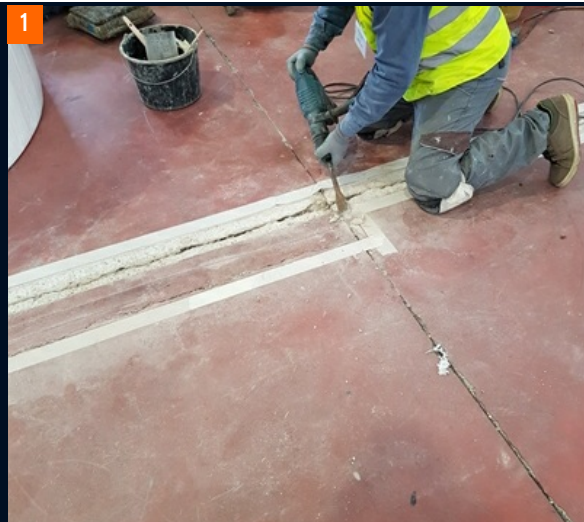
1. Remove detached concrete pieces and prepare grooves for repair along the crack lines
2. Cleaning after the preparation to remove dust and small debris
3. Belzona 4911 Conditioner applied to the exposed concrete substrate in the repaired area
4. Complete repair on a warehouse floor

To address damaged joints and cracks in the floor, a V-shaped groove needs to be cut out which is filled with Belzona 4111 (magma-quartz) mixture. Grooves are dug for each section, typically 6 mm to 10 mm deep, depending on the width and depth of the cracks. Exposed concrete surfaces were thoroughly prepared with a scarifier. After removing dust and impurities, the grooves were conditioned with Belzona 4911 (Magma TX conditioner). Finally, the mixed Belzona 4111 (Magma Quartz) was applied directly to the conditioned surface and finished by trowelling to smooth the surface.
