# BELZONA REPAIRS BALLAST TANK PERFORATIONS AT PORT SERVICE FACILITY

ID: 9292

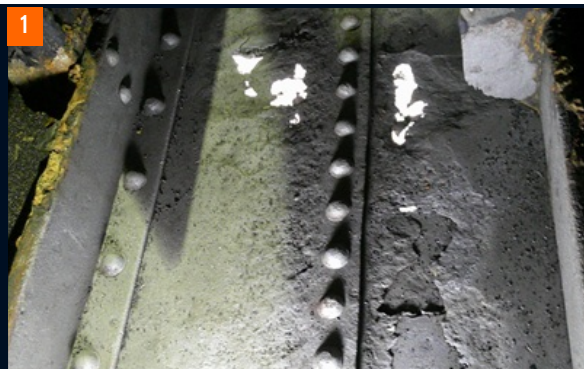
The ballast tanks at this port service facility were suffering from corrosion due to exposure to seawater. Previously, metal pads had been welded to repair perforations in the tank. However, this triggered bimetallic corrosion, apart from the original problem of saltwater corrosion. As a result, the corrosion continued and extended around the weld bead and under the welded pads, resulting in through-wall defects.

1. Extensive damage revealed at the tank bottom after blasting
2. First coated throughout with Belzona 5831LT and pit filled with Belzona 1818
3. Belzona 4151-silica mixture was poured over Belzona 5831LT and 1818
4. Complete application

After surface preparation by blasting, Belzona 5811 and 5831LT were applied to the prepared surfaces; Belzona 5811 was applied to the dry areas and Belzona 5831LT to the damp areas. Belzona 1818 was then applied to fill voids and low spots over the applied coating. As a final finishing touch to the repair, a resin rich mix of Belzona 4151 and silica aggregate was poured over the repaired areas to reinforce and level out the bottom.
