# QUICK TURNAROUND FOR CORRODED TANK USING BELZONA SOLUTIONS

ID: 9293

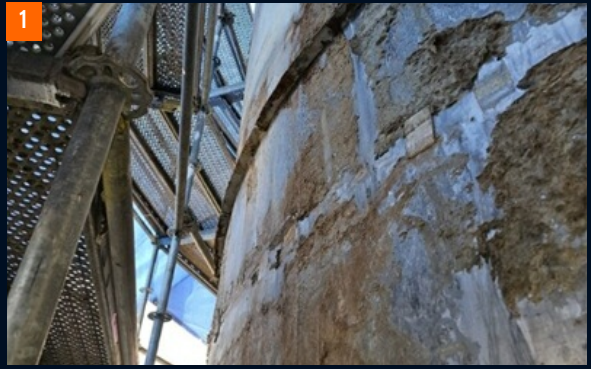
The Customer was experiencing weakening of their aluminium tank walls caused by corrosion for operational demineralised water.

1. Tank walls damaged caused by corrosion
2. Finished application

After the tank was blasted, we proceeded to replenish the pitting damages on the surface of the tank and then bandage the entire area with Belzona 1111 (Super Metal). Once the material had hardened, the surface was then prepared and Belzona 5811 (Immersion Grade) then applied in two layers. All the work was carried out on scaffolding with seven members of the application team as well as one inspector on site the entire application.
