# JET FUEL TANK'S PITTING CORROSION

ID: 9294

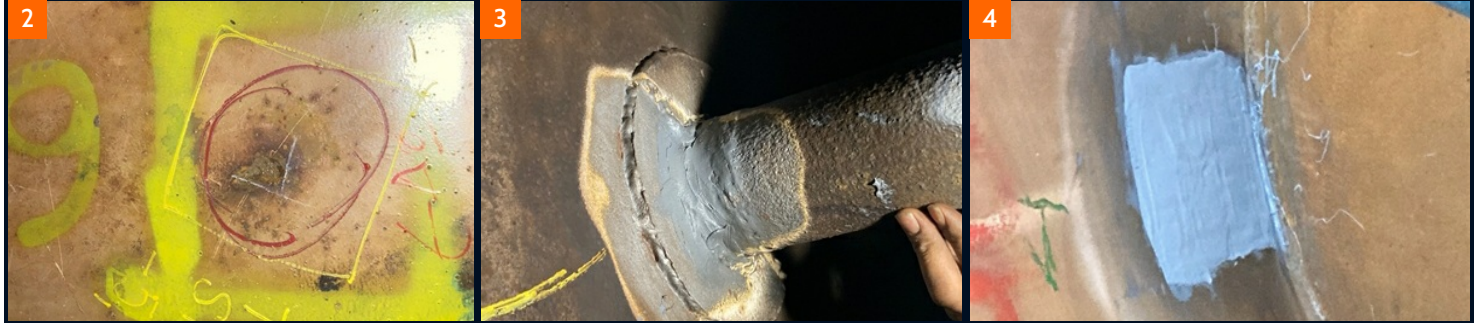
## PHOTOS

The Jet fuel tank had 14 points with pitting . The refinery wanted to fill up the tank with Jet fuel ASAP .

1. Big pitting with hole
2. pitting
3. After the application of Belzona 1161
4. Hole after the application

We used Belzona 9611 for the big holes and then Belzona 1161 to cover the pitting .

At the end we use Belzona 5811 for long term chemical resistance .
