# BELZONA PROTECTS SHIP EXHAUST

ID: 9296

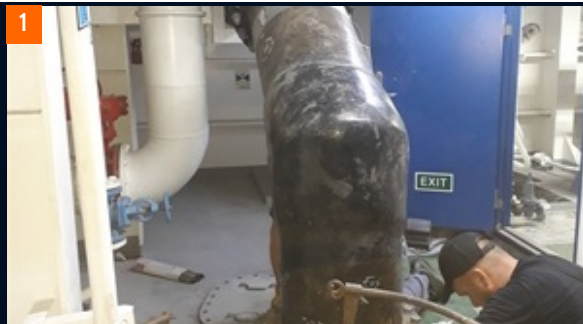
1. The steel pipe affected by scrubber exhausted emissions
2. Surface Preparation
3. Finished application after two coats of Belzona 1391T
4. Application after being inspected two years later.

Belzona 1391T, a high-temperature corrosion-resistant coating, was chosen to protect the affected steel pipes during a scrubber retrofit installation.
