# EXTENDING LIFE OF CEMENT BALL MILL USING BELZONA PRODUCTS

ID: 9299

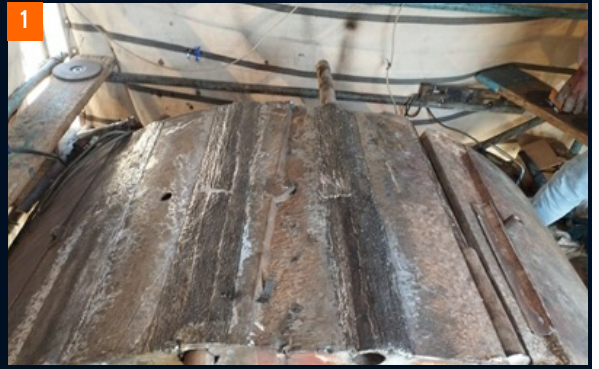
A cement ball mill was subjected to abrasions caused by the entrapment of cement particles under the mill tiles.

1. Damaged ball mill surface
2. Applying Belzona 1111
3. Aligning the tiles to be used as a mould
4. Application Complete

- The Tiles are removed from the surface of the ball mill
- The surface below is roughened to ensure maximum adhesion and then cleaned with a non-residual cleaner.
- The tile is then brushed with Belzona 9411 release agent
- Belzona 1111 is applied to the surface below the tile and the tile is aligned and left to cure accordingly
